Briarcliff : The Candler Mansion

October 16, 2023

Design and Preservation Approach

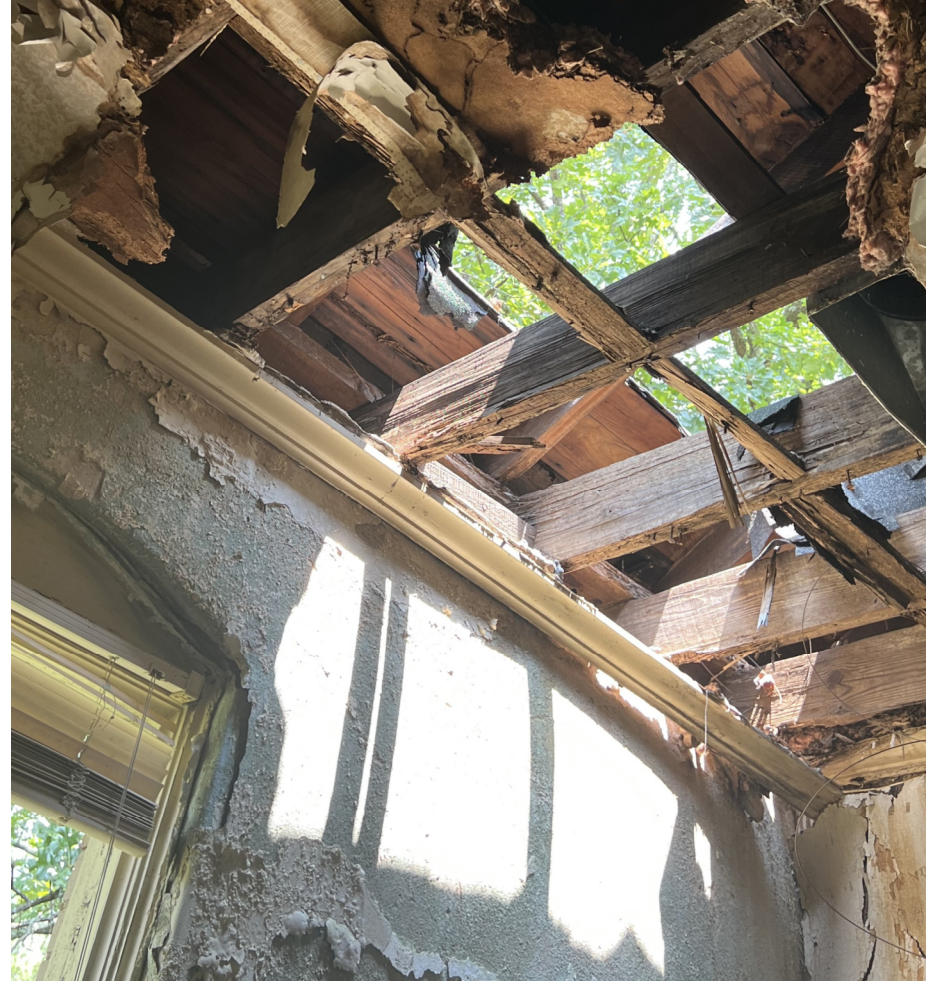
Condition - Structure

Masonry and Concrete Structure: No cracking, leaning, or other evidence of failures of the structure were observed. Investigative demolition thru damaged finishes and cores thru the structure at the locations of water damage should be performed to verify the integrity of these areas.

Wood Roof Structure: At the house, localized areas of damage caused by water infiltration exist and will need to be repaired. Extensive damage has occurred at the Carriage House Roof.

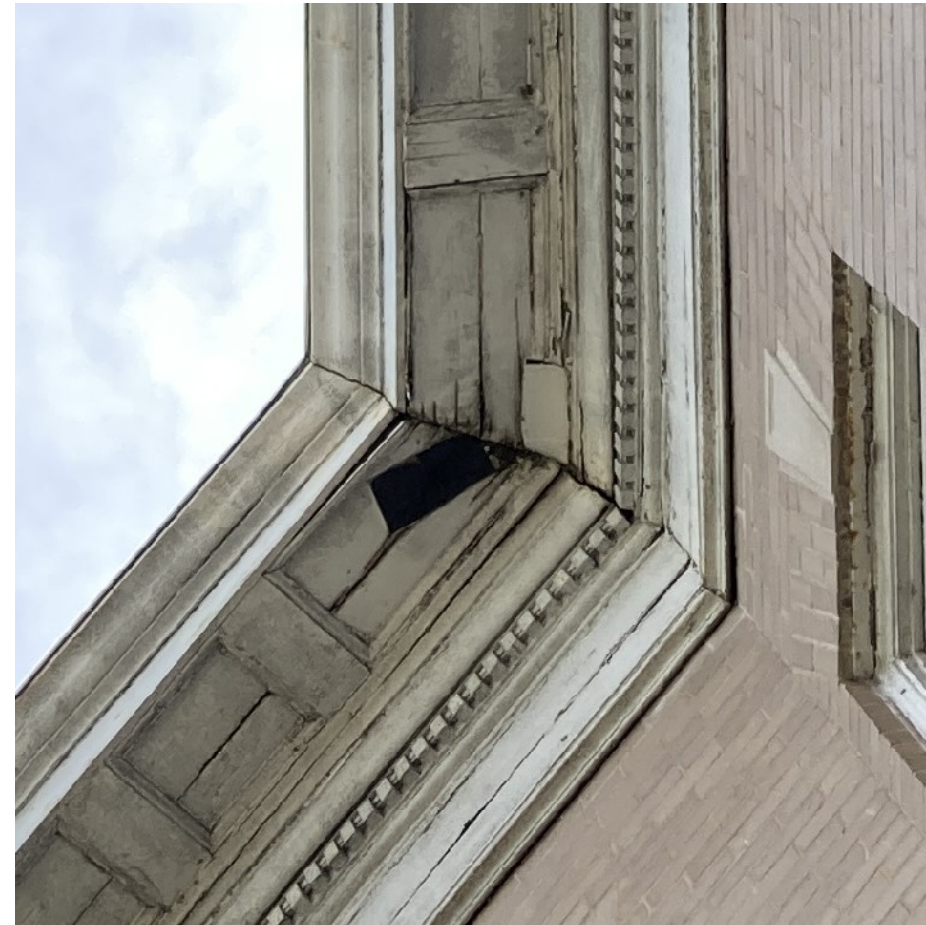
Condition - Exterior

Masonry: Minor repointing and brick/stone replacement needed. At the tile porches & walkways much of the perimeter stone edge needs to be removed and reset.

Woodwork: Portions of all exposed woodwork have deteriorated. Substantial portions of the wood cornices have deteriorated. Removal and reconstruction with matching wood or composition materials will be needed. All exterior woodwork to remain should receive extensive paint preparation before repainting.

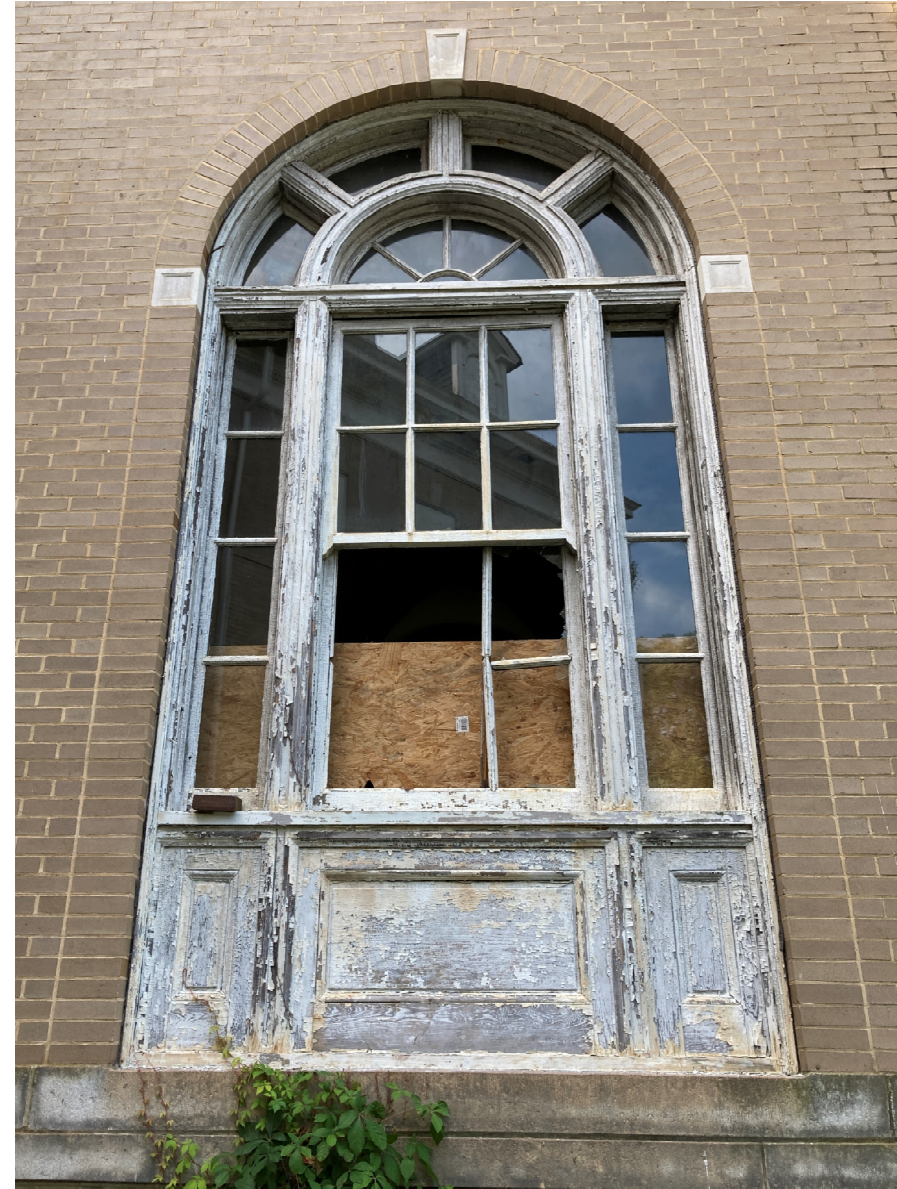
Condition - Exterior

Original Wood Windows: Wood windows are largely intact with only minor areas of decay observed. Some openings have been damaged by vandalism and building stabilization measures. Approximately 75% of glass needs to be replaced.

Original Steel Windows: The steel window systems at the Summer Pavilion and Music Hall/Banquet Hall addition appear to be in good enough condition that they can be stripped, repaired and remain in place. Full glass replacement should be anticipated as part of the restoration of these windows.

Replacement Windows: Non-conforming replacement windows should be removed and replaced with historically accurate windows as part of the rehabilitation.

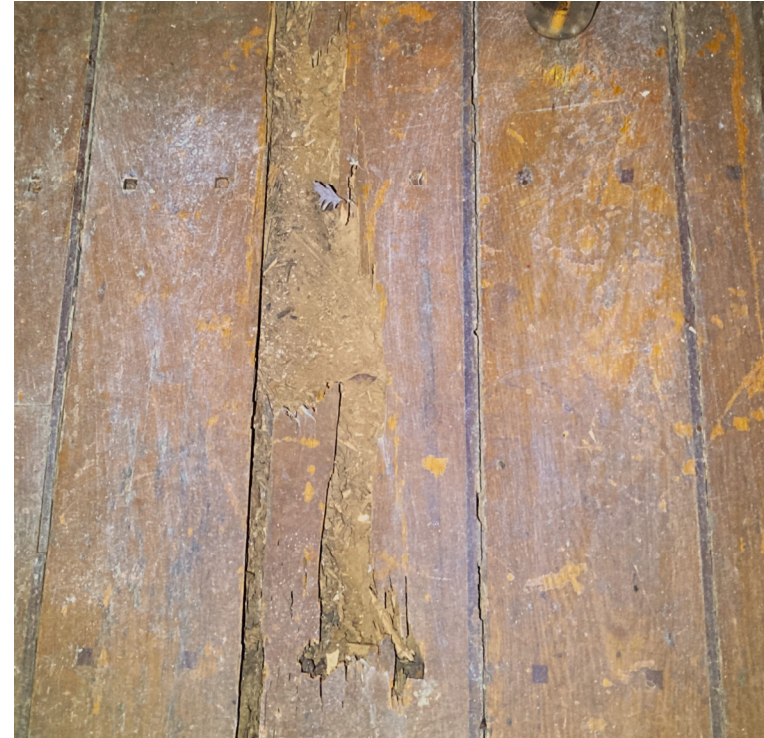
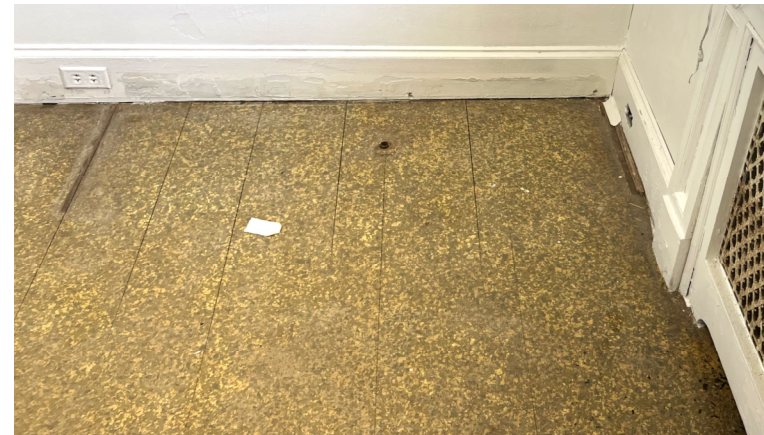
Condition - Interior

Wood Floors - First Level: 1 ½” tongue and groove oak floors at the main house and the 7” wide decorative plank floors at the Music Hall addition should be replaced, repaired and restored where damaged.

Wood Floors – Second and Third Level: Traffic Coatings and adhesives on the wood floors may be impractical to remove for refinishing original wood flooring.

Tile Floors – All Levels: Remove any coatings and restore.

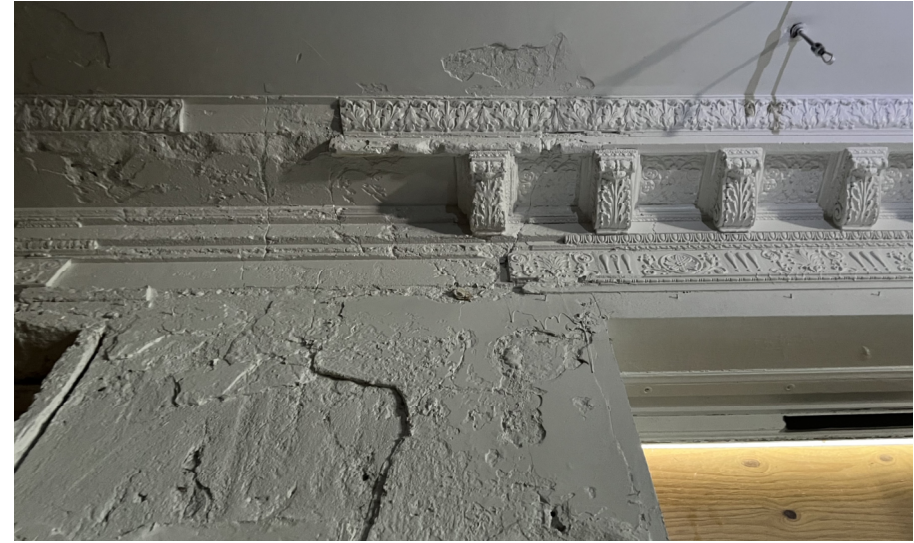
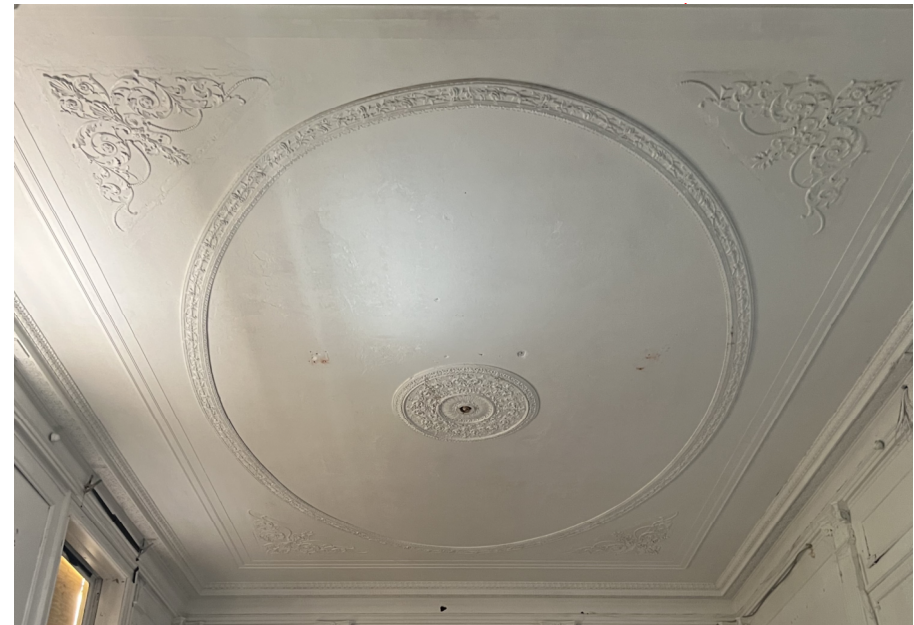
*Condition - Interior

Plaster Walls & Ceilings: Plaster walls, ceilings, and ornamental features are largely intact, They have been damaged slightly by institutional modifications made, and damaged severely in selected locations where water infiltration has occurred.

Wood Paneling: Wall and ceiling paneling at the Library and Music Hall have been subject to the same damage as the plaster walls/ceilings but have also been affected by 25 years of temperature and humidity in the unconditioned building.
