# **REPORT OF TEST PIT EXPLORATION**

Cassville Road Property

Cartersville, Bartow County, Georgia

WSP Project No. 6162232474

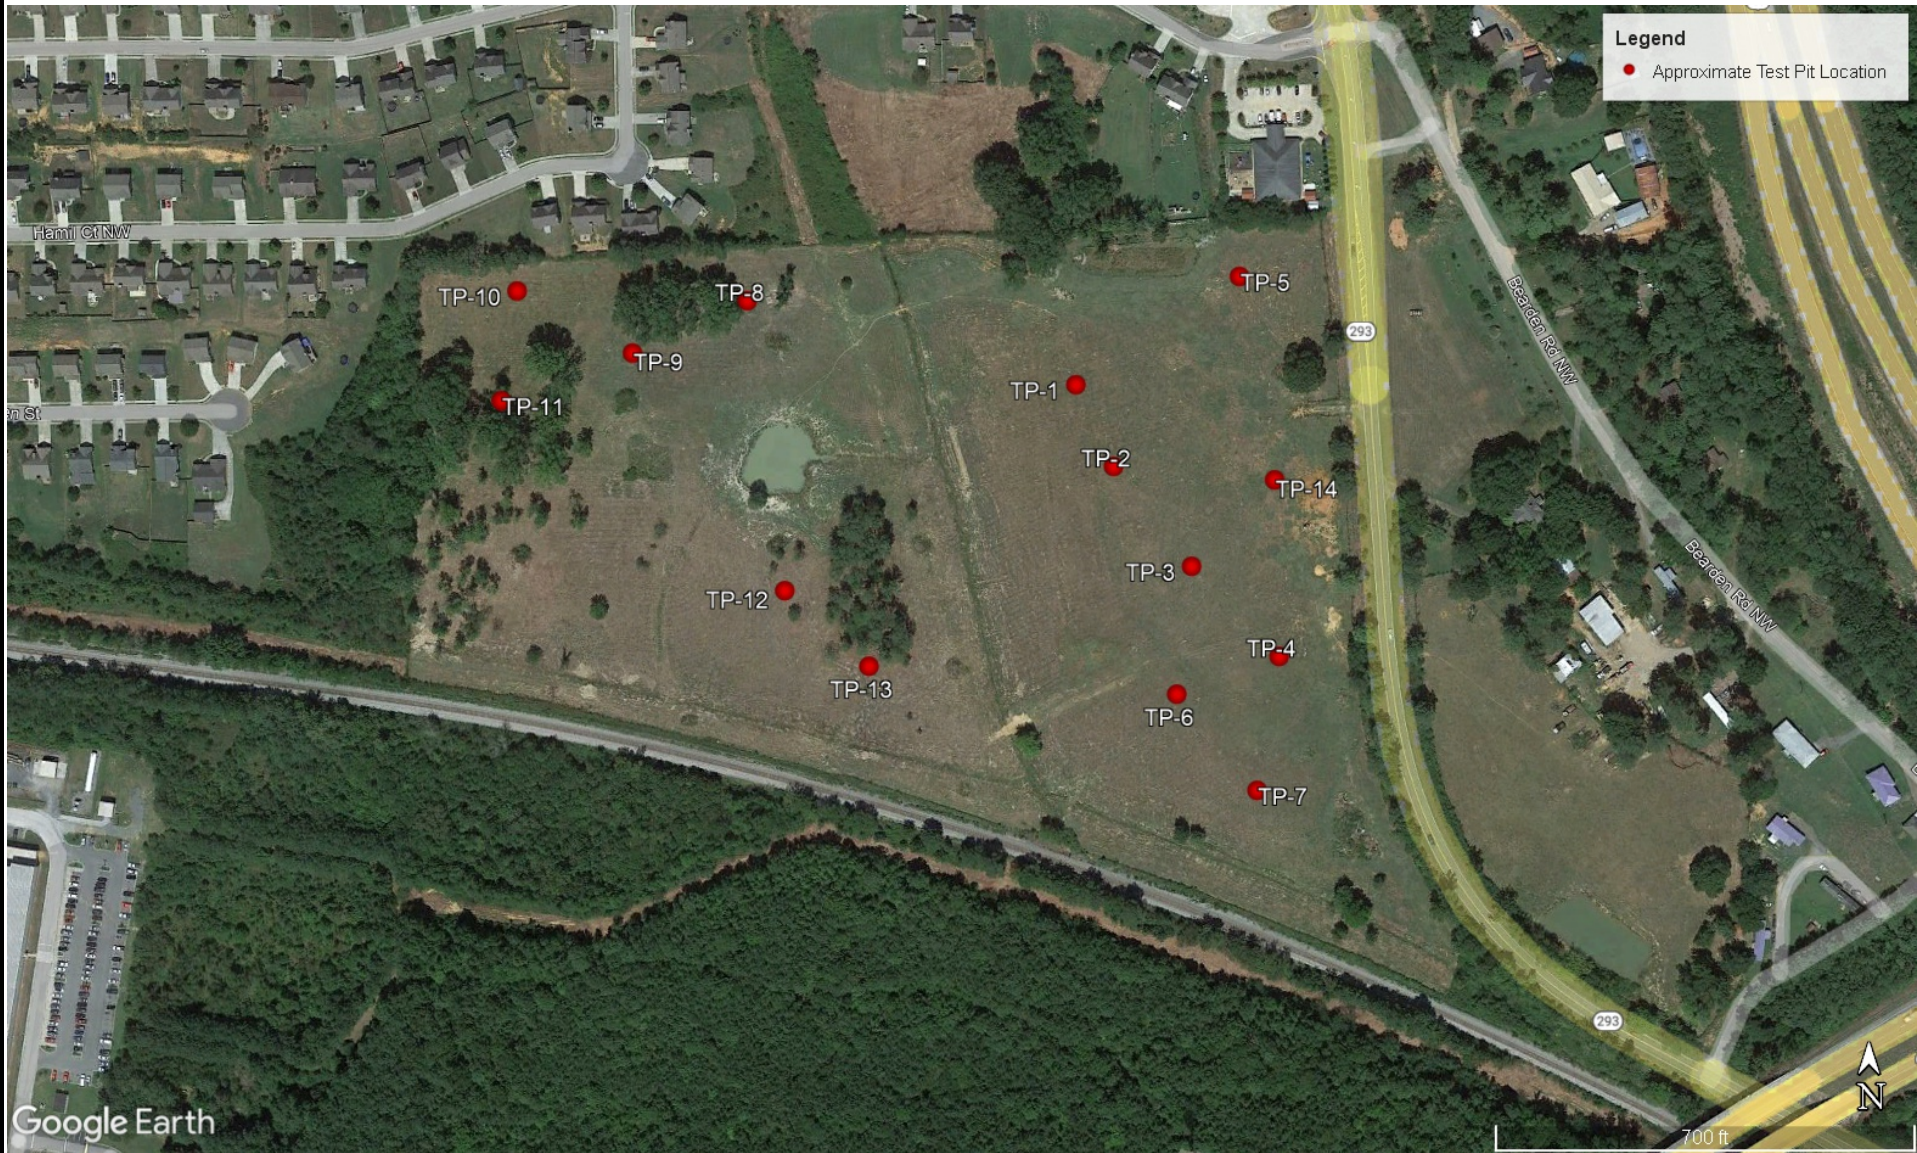
FIGURE 1

**TEST PIT LOCATION PLAN**

The locations were spaced throughout the site based on the location plan provided. Figure 1, Test Pit Location Plan, in the Appendix presents the approximate locations of the test pits completed for this exploration. These locations were established in the field by WSP personnel using a hand-held Global Positioning System (GPS) and referencing existing site features.

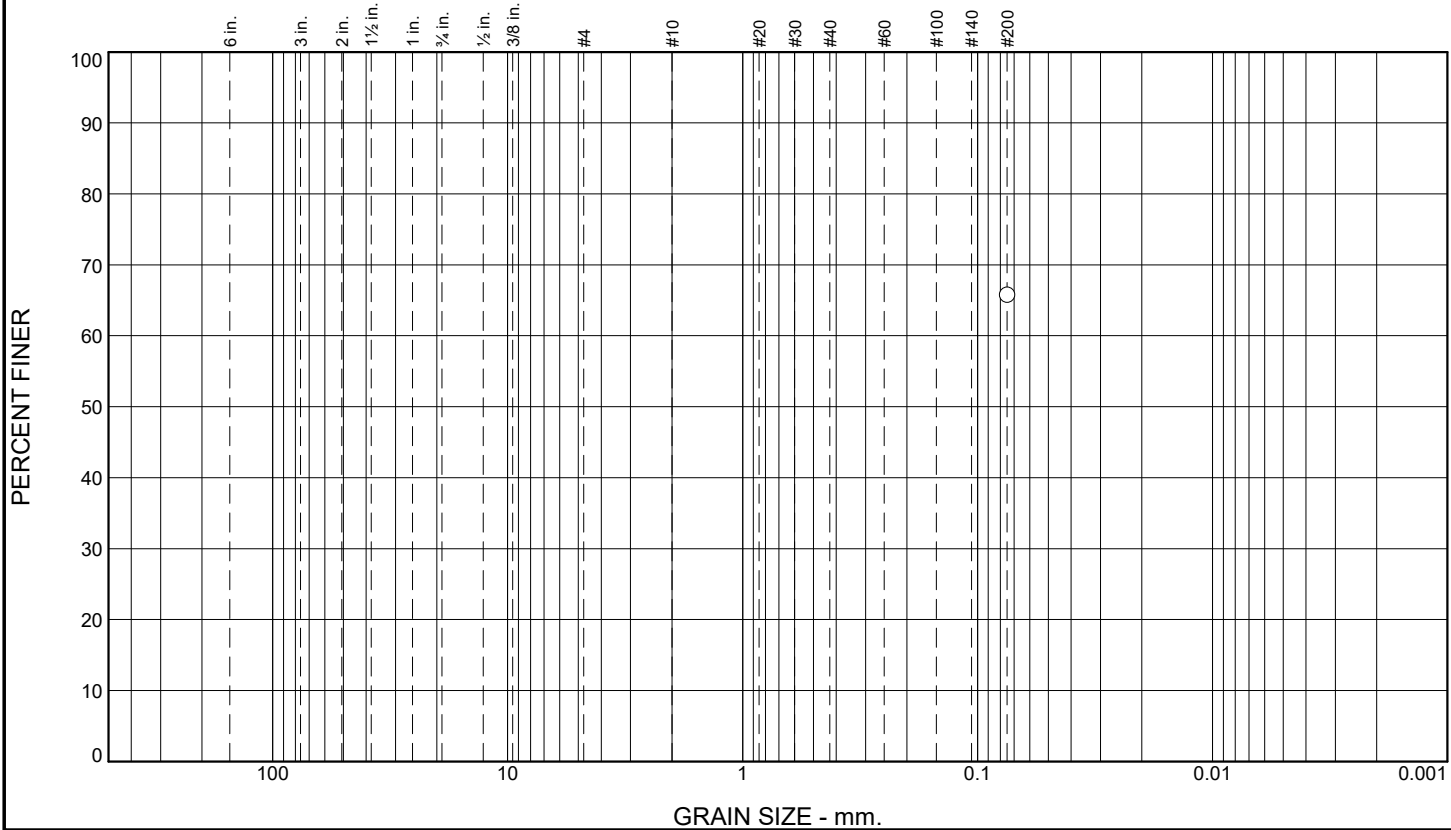
Material Description		
Gray and Tan Sandy Fat CLAY		
<b>Atterberg Limits</b>		
PL= 22	LL= 56	PI= 34
<b>Coefficients</b>		
D <sub>90</sub> =	D <sub>85</sub> =	D <sub>60</sub> =
D <sub>50</sub> =	D <sub>30</sub> =	D <sub>15</sub> =
D <sub>10</sub> =	C <sub>u</sub> =	C <sub>c</sub> =
<b>Classification</b>		
USCS= CH	AASHTO= N/A	
<b>Test Remarks</b>		
Lab # 23418		
As Received Moisture Content = 19.8 %

Source of Sample: 6      Depth: 3-6 ft  
 Sample Number: 1

It should be noted that the fat clays (CH) encountered on site in TP-6 should not be reused as structural fill material due to the high plasticity unless it is mixed with sandy soils to reduce the plasticity. Mixing of high-plasticity soils should be performed under the direction of the Geotechnical Engineer of Record. It may be feasible to use these soils in deeper fills or in non-structural areas, however, we recommend that a vertical separation of at least two feet be maintained between structure slabs or pavements and the high-plasticity soils. While not identified on-site elastic silts (MH) are common to the area and should also be mixed with other sandy soil types if used as structural fill.

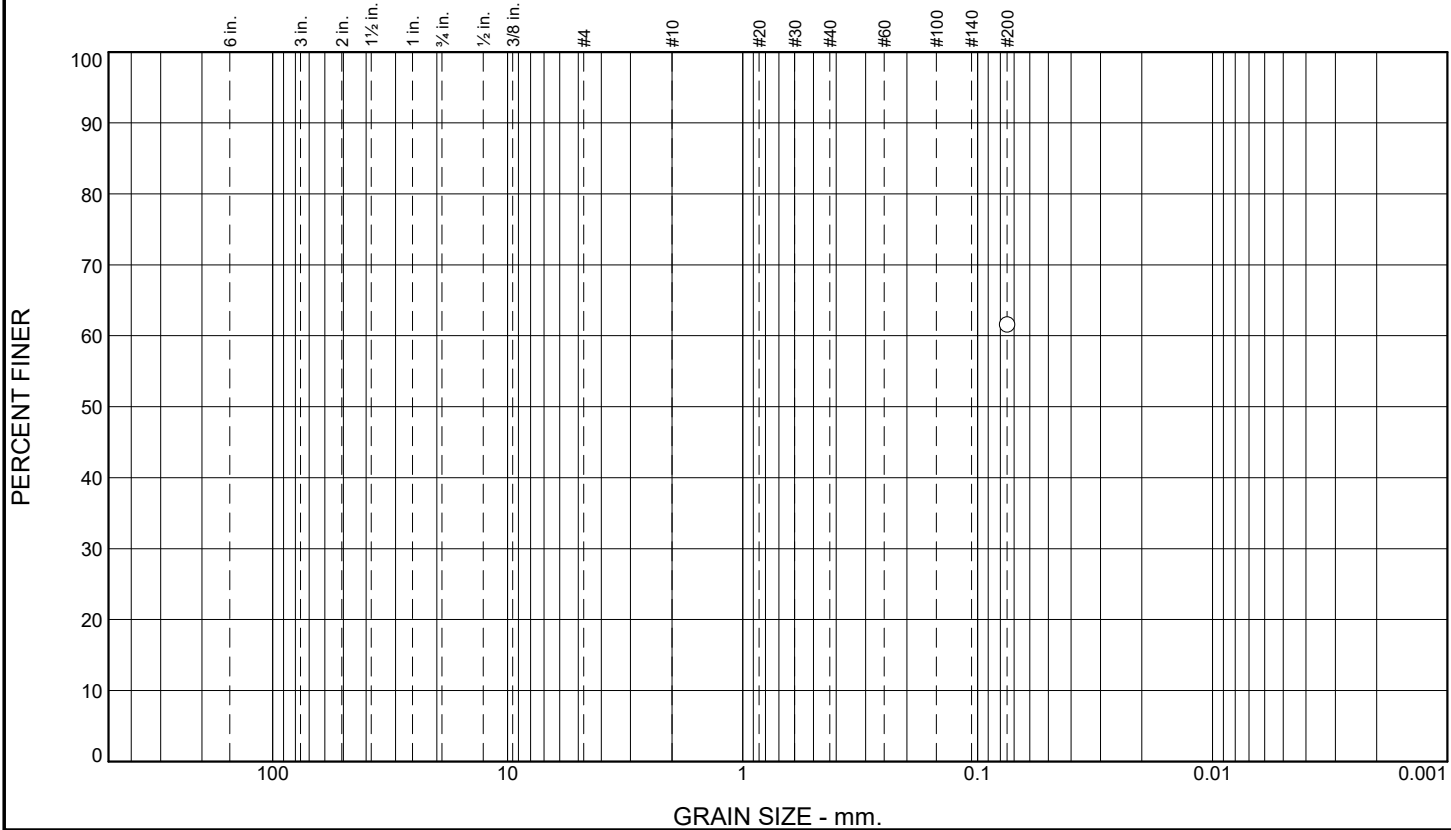
Reddish Brown Sandy Lean CLAY

PL= 27      LL= 45      PI= 18

USCS= CL      AASHTO= N/A

Source of Sample: 1      Depth: 0-2 ft  
 Sample Number: 1

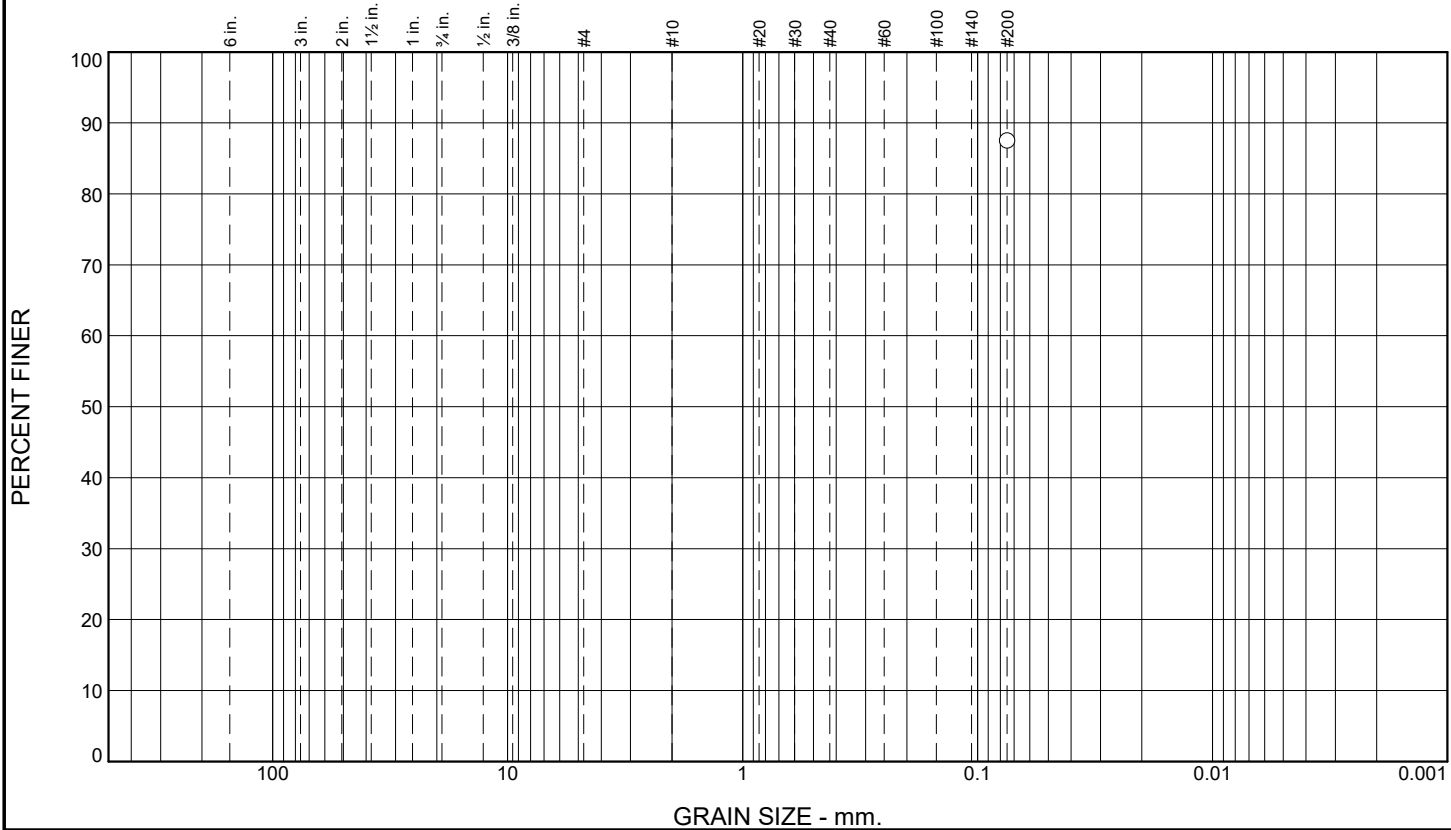
Material Description		
Red Lean CLAY		
<b>Atterberg Limits</b>		
PL= 25	LL= 44	PI= 19
<b>Coefficients</b>		
D <sub>90</sub> =	D <sub>85</sub> =	D <sub>60</sub> =
D <sub>50</sub> =	D <sub>30</sub> =	D <sub>15</sub> =
D <sub>10</sub> =	C <sub>u</sub> =	C <sub>c</sub> =
<b>Classification</b>		
USCS= CL	AASHTO= N/A	
<b>Test Remarks</b>		
Lab # 23420		
As Received Moisture Content = 23.5 %

Source of Sample: 14      Depth: 2-6 ft  
 Sample Number: 1

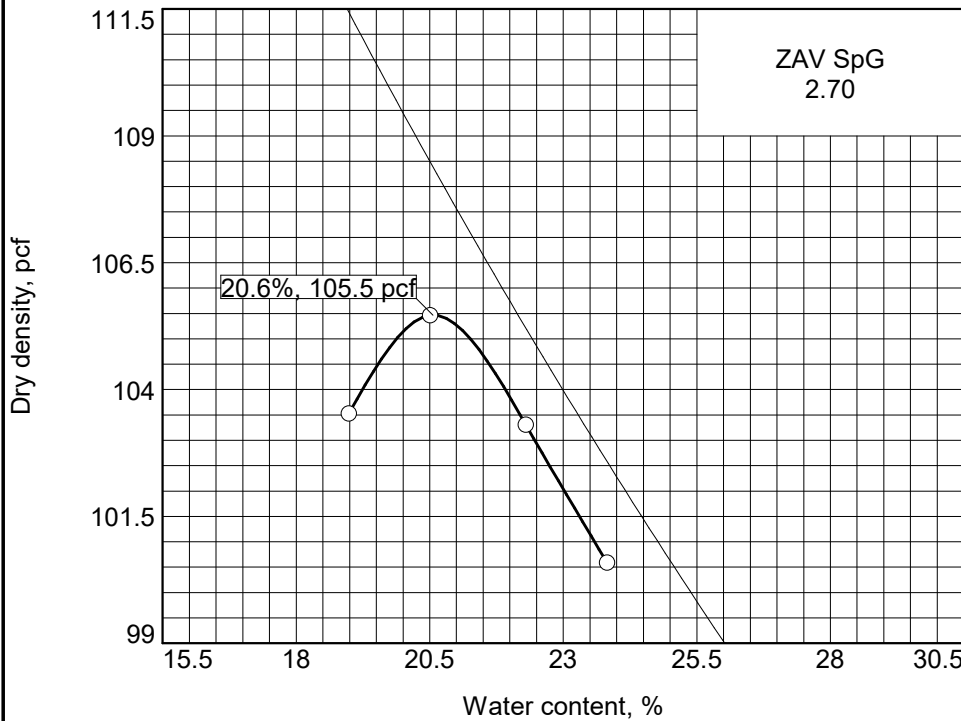
ASTM D 698-12 Method A Standard

Optimum moisture = 20.6 %

Moisture contents in comparison to standard Proctor optimum moisture indicate soils are 2 to 3 percent above the optimum range. As such, some drying of the materials may be required depending on conditions at the time of construction. Such drying is more easily accomplished in hotter dryer months and may be impractical during wetter periods of the year.

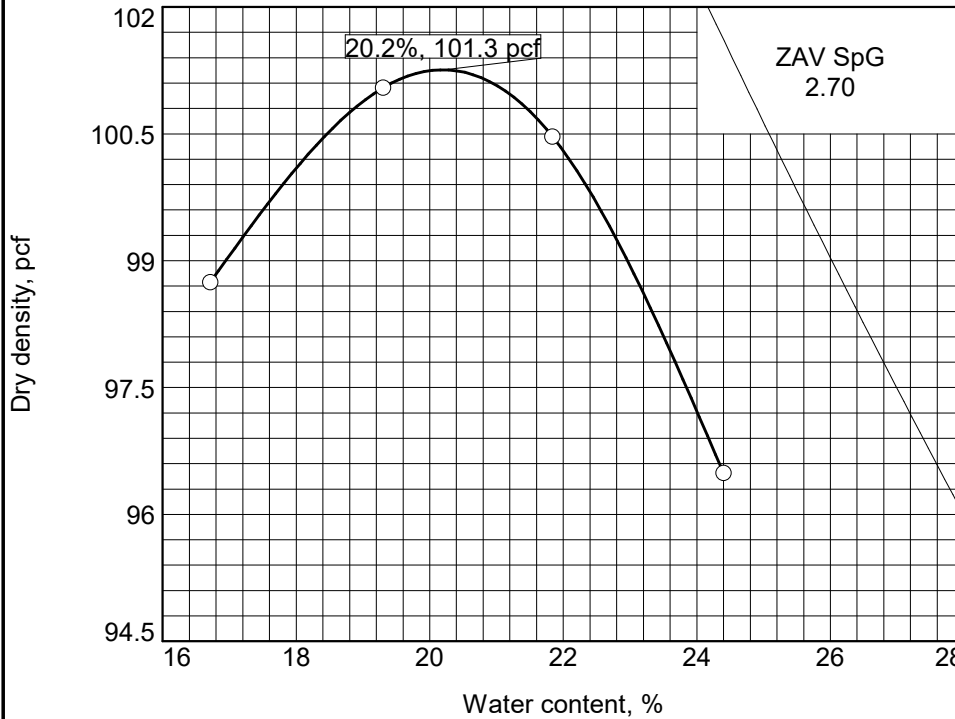
ASTM D 698-12 Method A Standard

Optimum moisture = 20.2 %

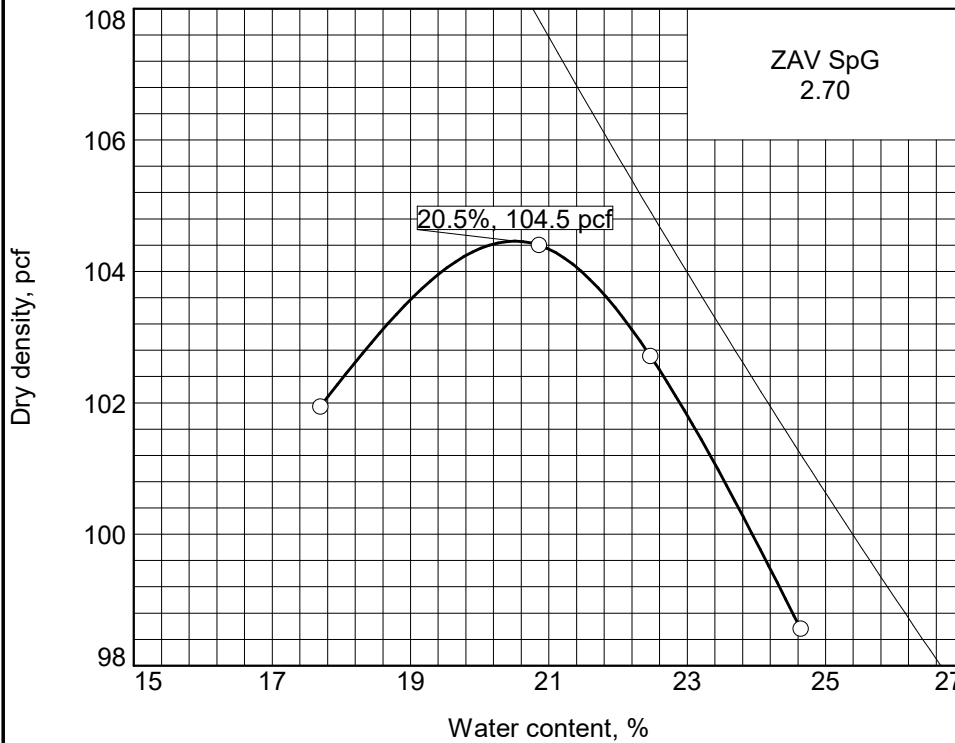
ASTM D 698-91 Procedure A Standard

Optimum moisture = 20.5 %

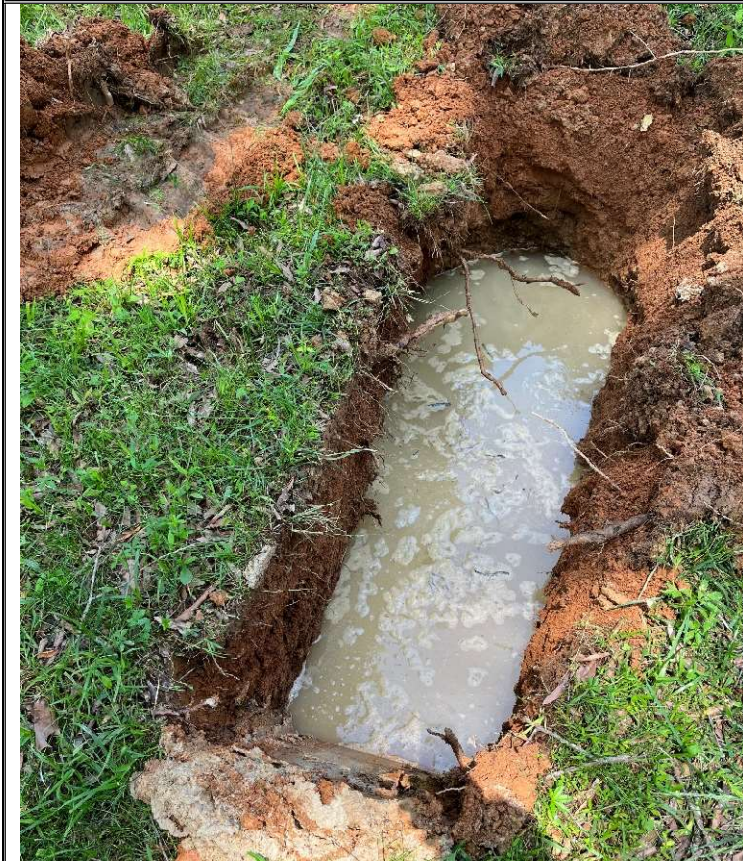
**Test Pit 11  
Stabilized Groundwater**

Test pits 2, 11, and 11-A encountered groundwater during the field exploration at depths ranging from 2 feet to 4 feet below grade. Groundwater was actively flowing into the test pits during excavation.

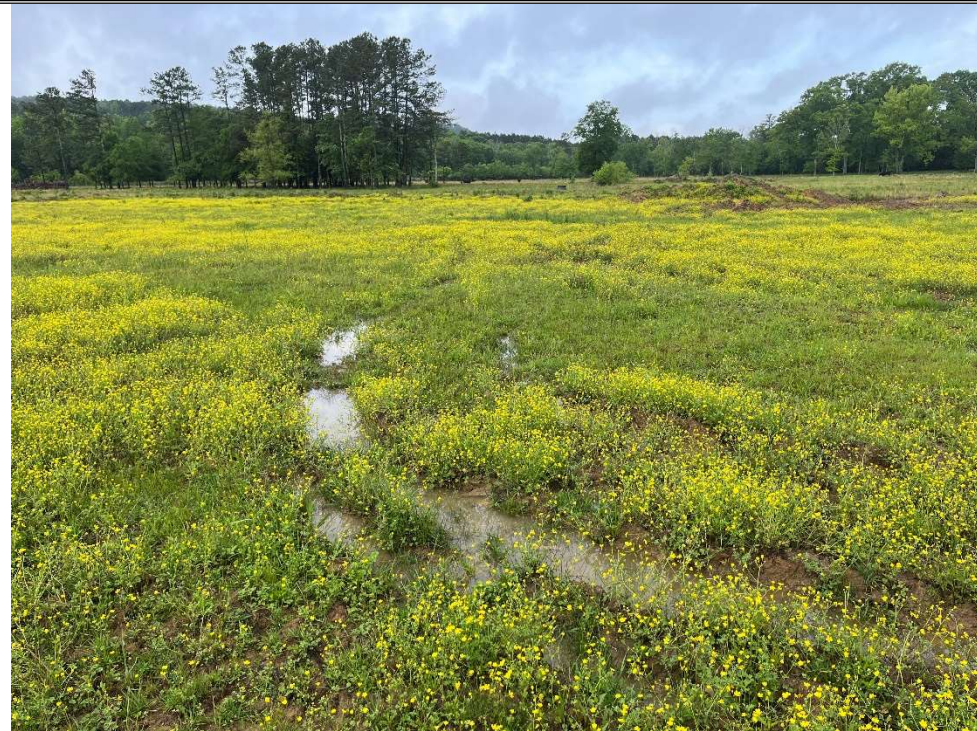
**Standing Water**

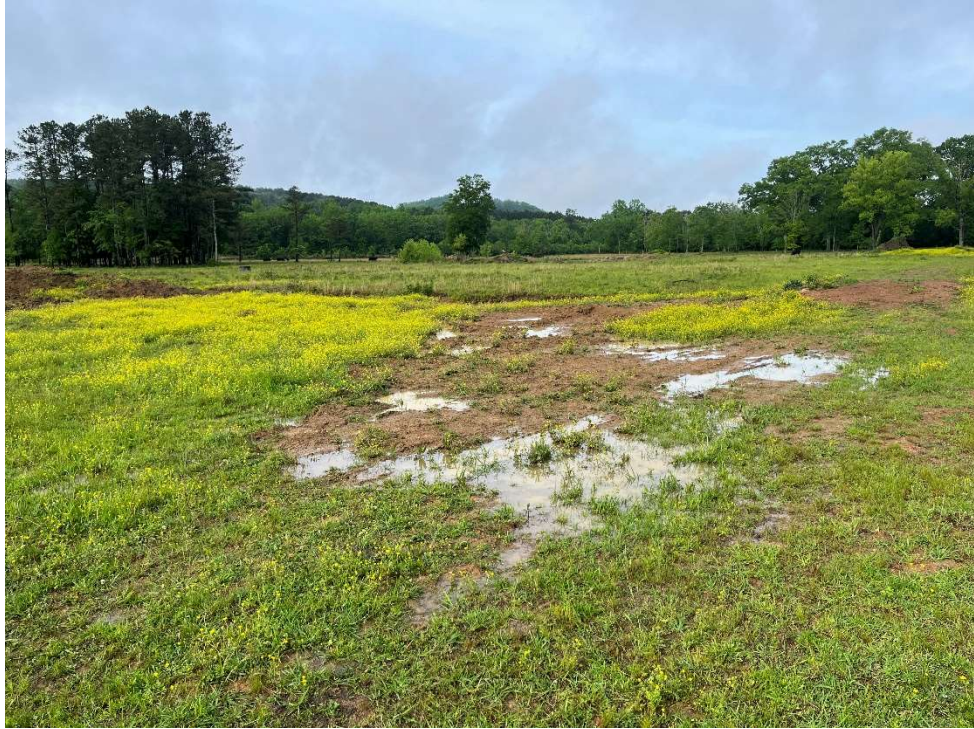
**Comment:**  
**Standing Water**

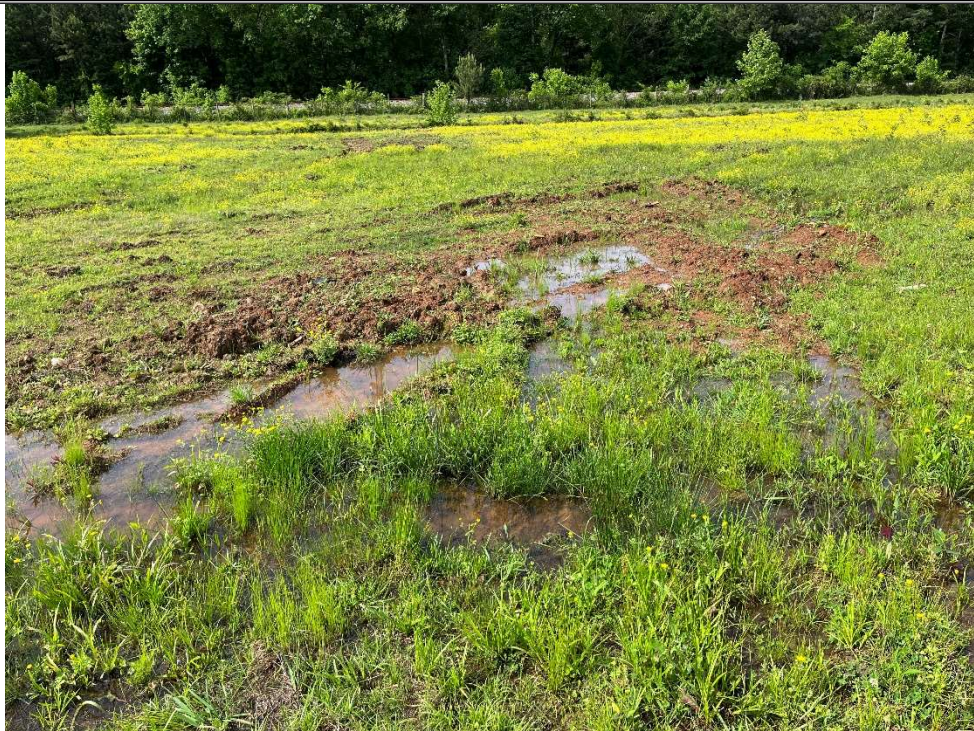
**Comment:**  
**Standing Water**

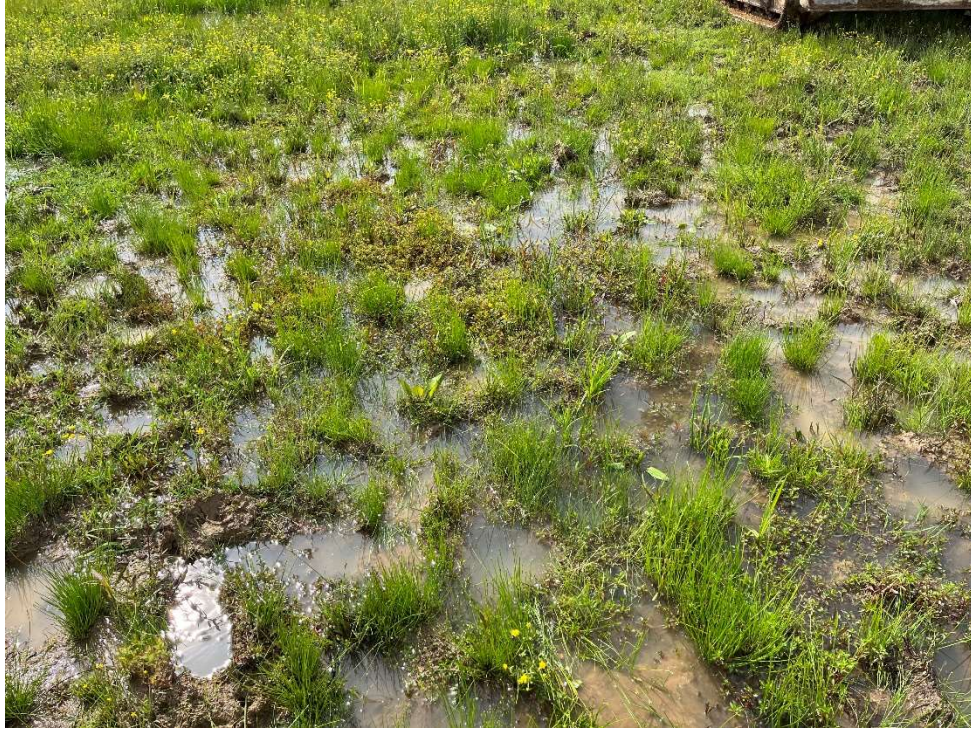
**Comment:**  
**Standing Water**

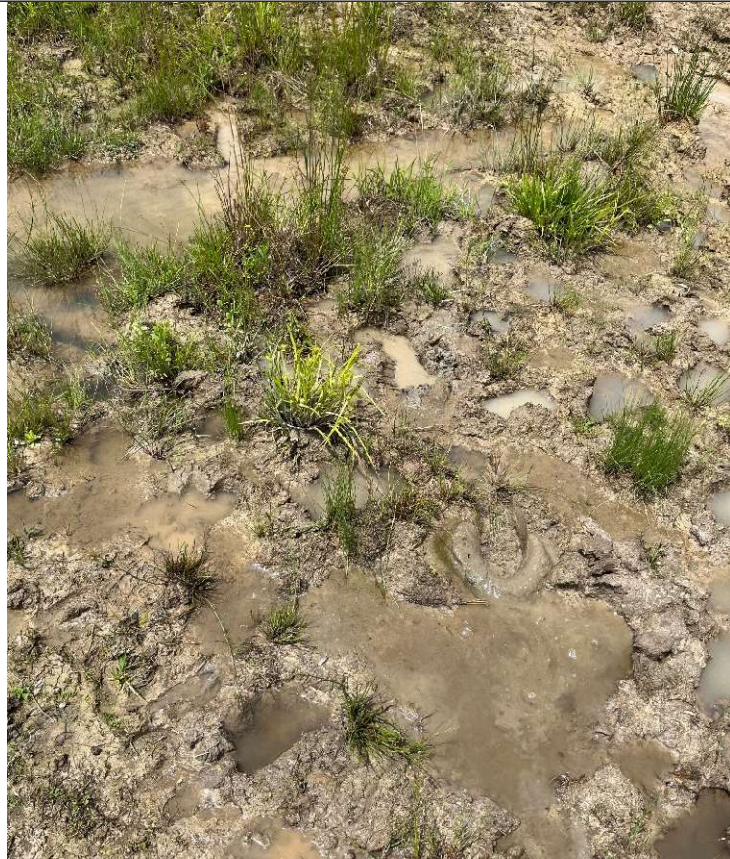
**Comment:**  
**Standing Water**
