## **State Waters & Wetland Delineation Report**

**Old Eatonton Road Tract  
Old Eatonton Road  
Greensboro, Georgia 30642**

**May 14, 2024**

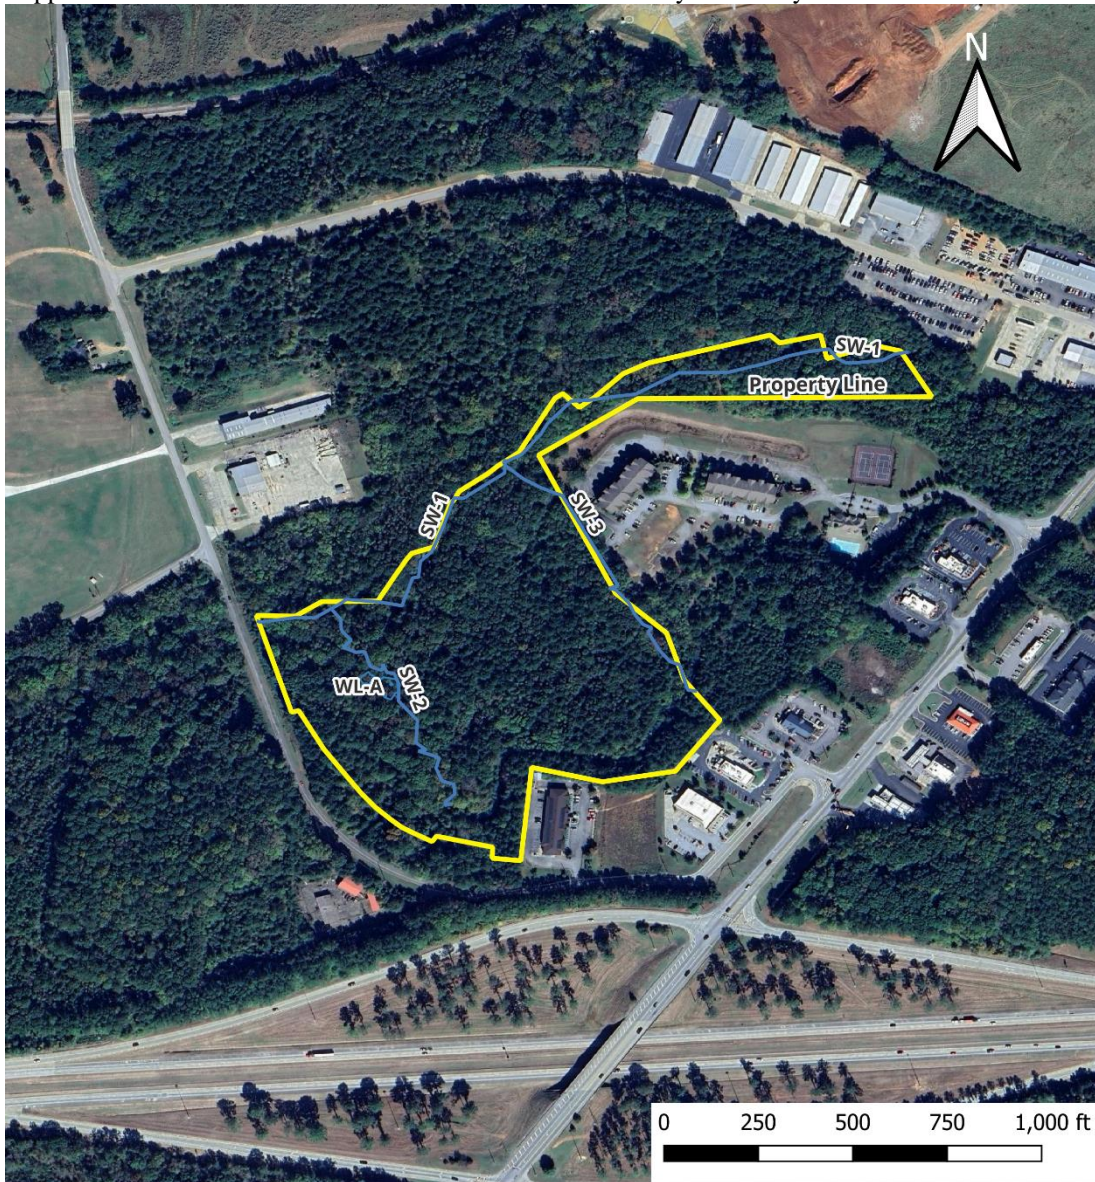
# Feature Locations

Approximate locations of features – need field confirmation by the survey team to finalize locations.

Data for this map was gathered on May 14, 2024, using a Garmin GPSMap 65s device that had an accuracy reading of 10ft during the delineation. This map is intended to show the general size and location of the features and is not intended to be used for engineering or design purposes.

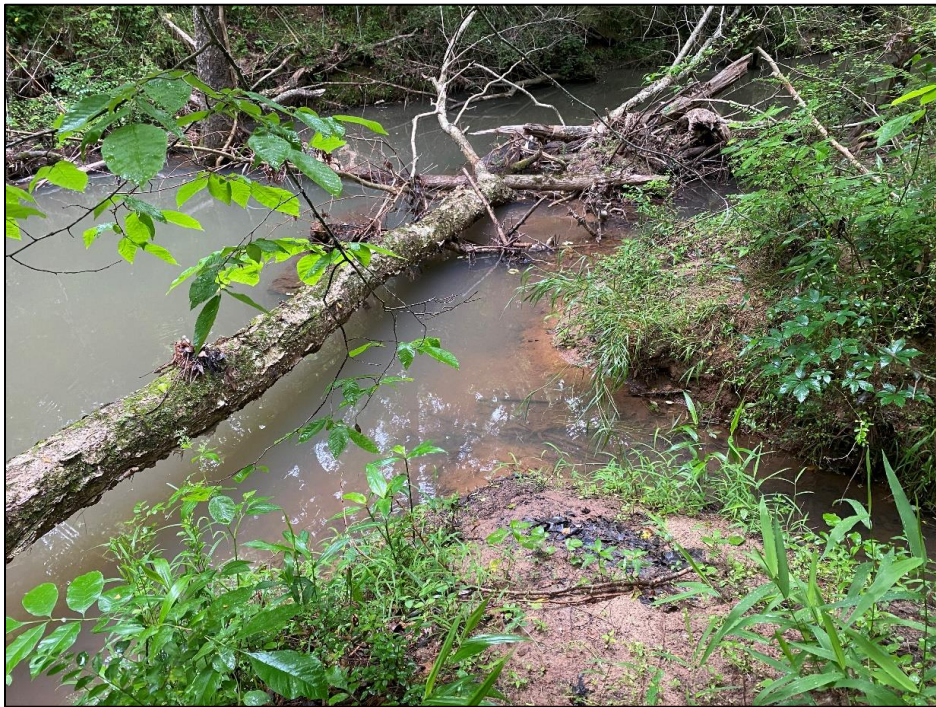
**SW-2 merges to SW-1**

Feature #	Label	Description of origin, the direction of flow, and terminus.
1	SW-1	This feature known as Town Creek enters the tract on the northeastern side and flows west, exits the tract, then flows south along the western border where it leaves the tract on the western corner.
2	SW-2	This feature enters the tract on the southern side of the tract and flows west and merges into SW-1.
3	SW-3	This feature enters the tract on the eastern border and flows northwest along the property and merges into SW-1, where the property is narrow.
4	WL-A	This feature is a small wetland on the south side of SW-2.

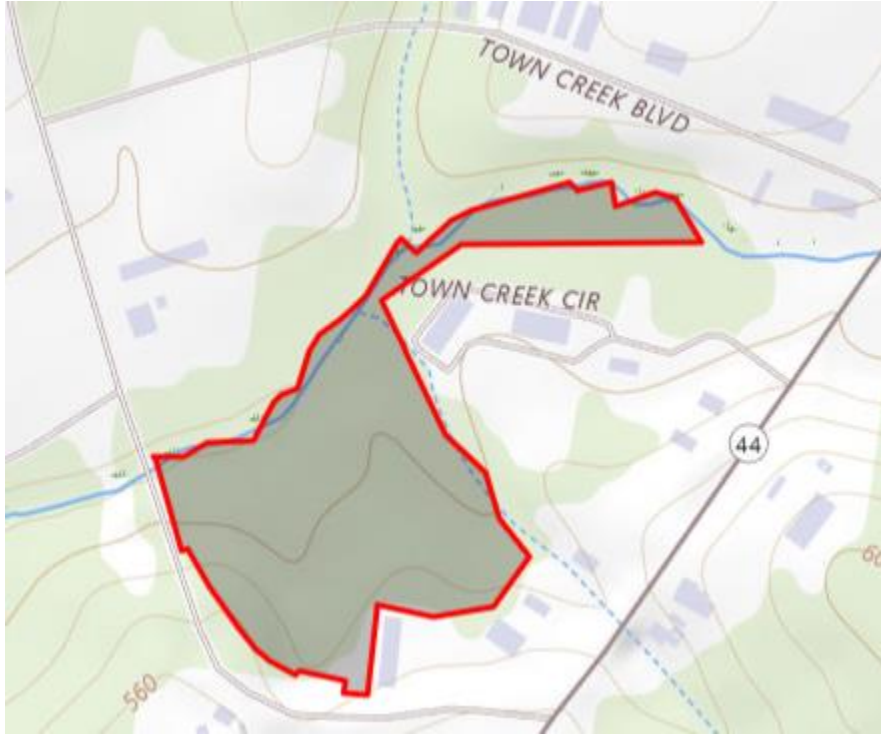
# Topography Map

The site under study is located on rolling hills with a general slope to the west. See the topographic map.

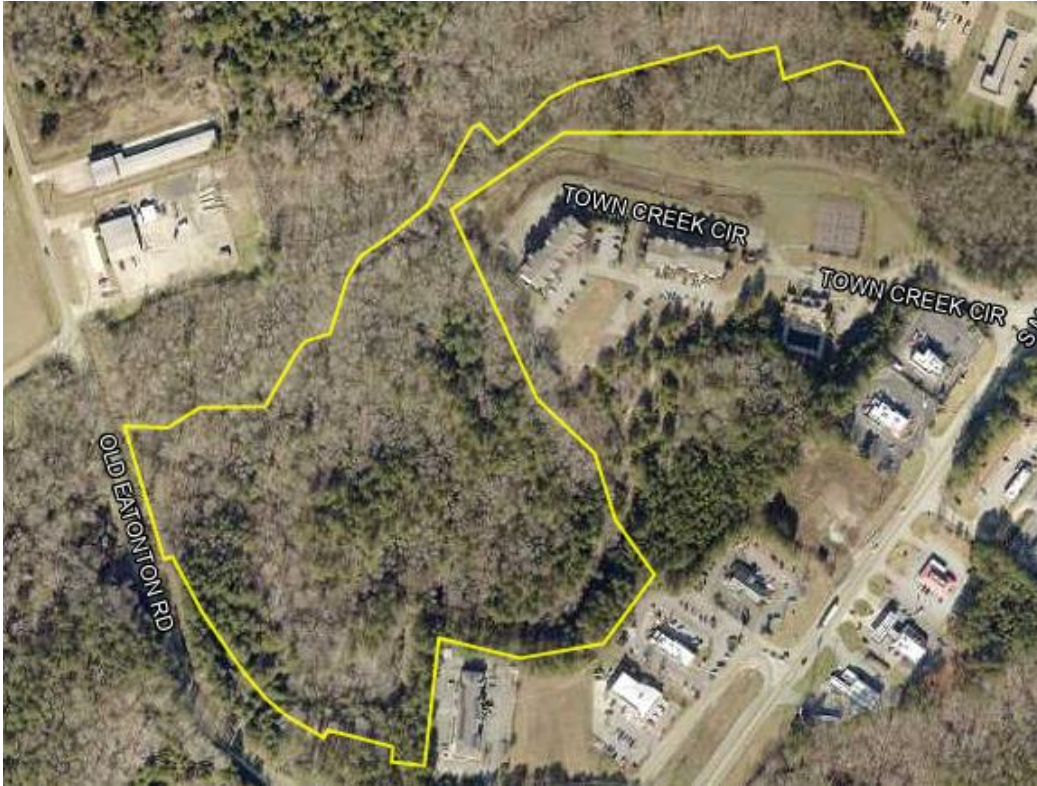
**Aerial photograph of the site**

Presently, the Old Eatonton Road property under evaluation is residential property with commercial and residential properties surrounding. See the aerial photo of the site.
